**U.S. Department of the Interior
Bureau of Land Management
White River Field Office
73544 Hwy 64
Meeker, CO 81641**

LAND HEALTH ASSESSMENT

NUMBER: CO-110-2006-055-EA

LOCATION: Wolf Creek Watershed-Three Springs Ranch (0501447)

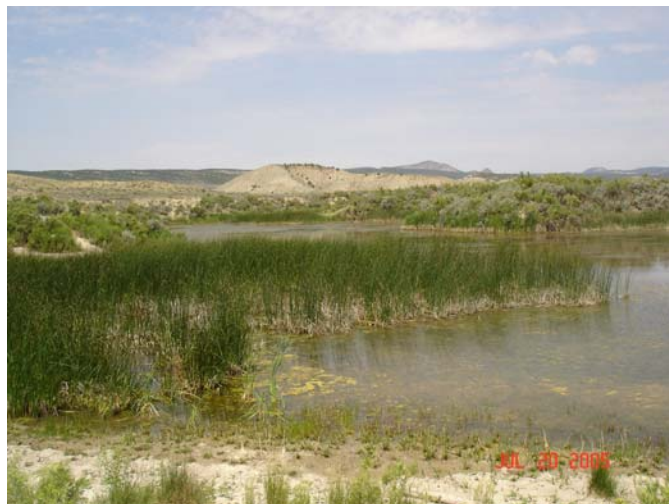
Figure 9: Peterson Draw Reservoir #1 (7/2005)

Reservoir #1 (figure 9) is located within the drainage and is largely filled in with sediment, thus limiting its water holding capacity.

The riparian zone is largely limited to the channel above the reservoir. Dominate riparian plants include cattails, limited willows, sedges, and bulrushes, with limited tamarisks and a couple of Russian olives. Sedges provide a nearly continuous cover throughout the system. Also, perennial pepperweed (tall whitetop), an invasive and noxious weed, is found within this drainage on a limited basis. The saturation zone of the channel is expanding laterally, as there are juniper trees within the channel that have recently died (over saturation). An apparent causative factor

for this lateral expansion may be due to the reservoir being full of sediment, thus water is not accumulating within the reservoir and the water is being forced to saturate the soils upstream of this reservoir. Overall, this riparian section received a rating of Proper Functioning Condition with concern over the occurrence of perennial pepperweed which is present, not dominate, within the plant community.

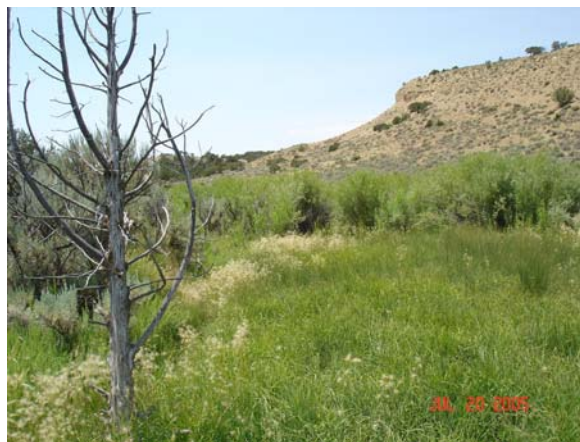
Figure 10: Three Springs Draw (7/2005)

The riparian zone within Three Springs Draw/Yellow Cat Draw (figure 10) is similar to that of Peterson Draw #1 (figure 9) and was inventoried for PFC in July of 2005. The riparian community on BLM administered lands is supported and obligated to upstream flowing water wells located on private land. Dominate riparian plants include sedges, rushes, cattails, and willows. Willows of all age classes are more dominate within this channel then that of Peterson Draw. The saturation zone of the channel is expanding laterally, as there are juniper trees

within the channel that have recently died (over saturation). Overall, this riparian section is similar to that of Peterson Draw and is functioning.

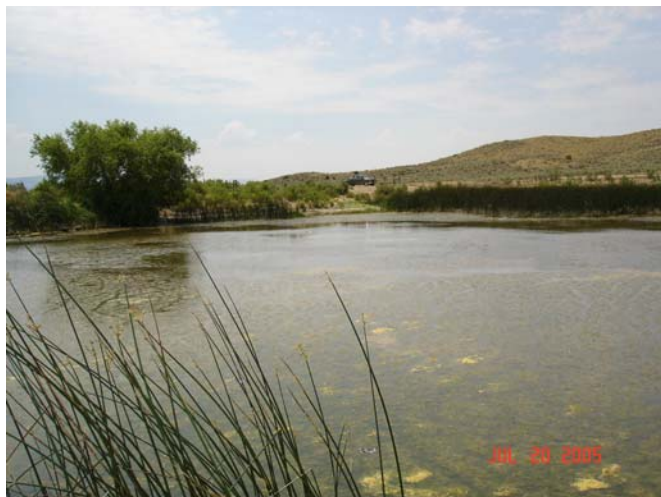
Figure 11: Peterson Draw Reservoir #2 (7/2005)

Peterson Draw Reservoir #2 (figure 11) supports a lentic (standing water) riparian community along the shoreline (3 acres) in the Wolf Creek Pasture. Dominate plant communities include bulrushes and cattails. Peterson Draw Reservoir #2 was inventoried for PFC during July of 2005, 2004, and 2002. During all inventories, the area was rated as Proper Functioning Condition. This reservoir is fed by an underground source and is subject to low water levels and at times may go dry. A fenceline (#1112) surrounds the reservoir, but a lack of adequate maintenance has

allowed cattle to access the site. Cattle are typically entering the site for watering purposes at the dam location and then exiting the site using the same route. Outside of the dam, cattle make little use of the riparian system. As shown by the functional rating, cattle are having no discernable effect on the functionality of the riparian system.

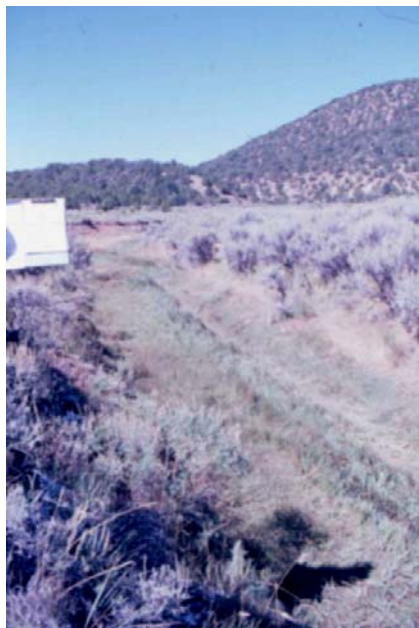
Figure 12: Wolf Creek reach #1 (9/1995)

The Wolf Creek drainage was inventoried for PFC in September of 1995. Four segments were delineated during this inventory, however only one segment for 1 mile (reach #1, figure 12) had intermittent riparian characteristics, which has private land above and below the segment. The remainder of the drainage (reach #2-4) did not express riparian characteristics on BLM administrated lands. Reach #1 was rated as Functional-At Risk with a Not Apparent trend due to a straight streambed within a slight gully.

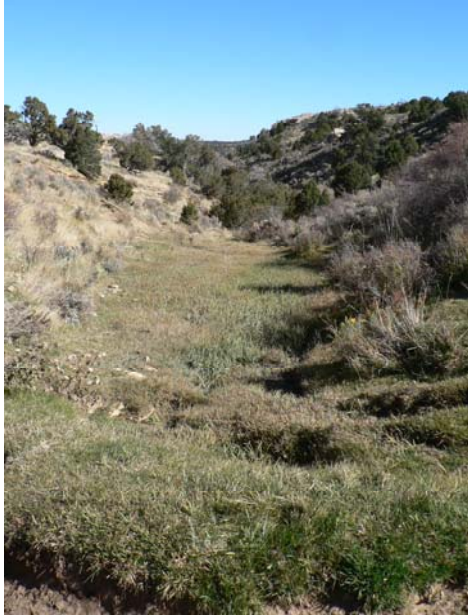
Figure 13: Bear Canyon (10/2005)

The Bear Canyon drainage was inventoried for PFC in July of 2005 and September of 1995. Five segments were delineated during these inventories, however only one segment for 0.9 miles had riparian characteristics throughout much of the reach. Riparian plant species within the reach include rushes, sedges, redtop, Kentucky bluegrass, and a few box elder trees.

During the 1995 inventory of Bear Canyon, the riparian reach was rated as Functional-At Risk with a downward trend due to a recent thunderstorm flow event (the day before the inventory) that flattened and uprooted a portion of the riparian community and due to a headcut at the base of the reach which ends at a rock face. The 2005 inventory rated this reach (figure 13) as Functional- At Risk with an upward trend. A few small headcuts (drops of ½ ft. to 2 ft.) are present near the spring source in the channel, which are partially reinforced with riparian vegetation (sedges). The inventories classified the segment as having a riparian zone that has achieved its potential extent with a diverse composition of riparian vegetation that exhibit high vigor and present species indicate maintenance of riparian soil moisture. The spring sources are developed with short pipelines feeding two water troughs, which serve as the primary water source for

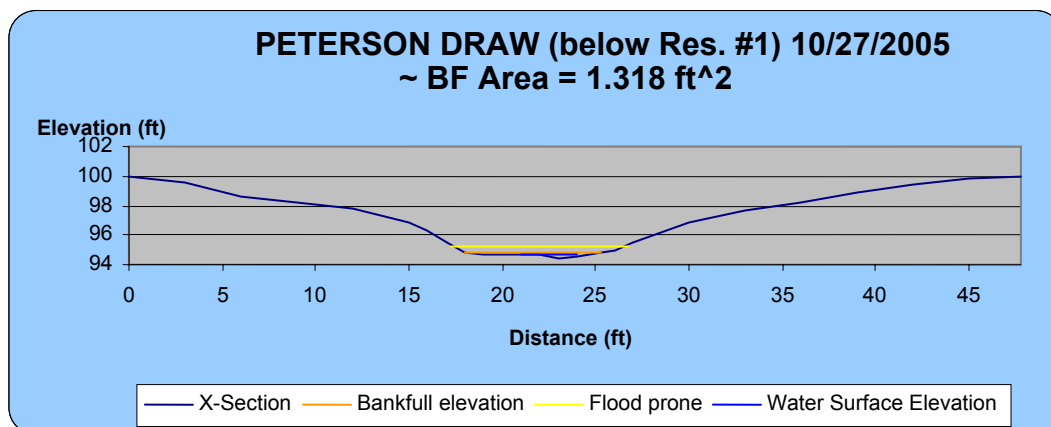
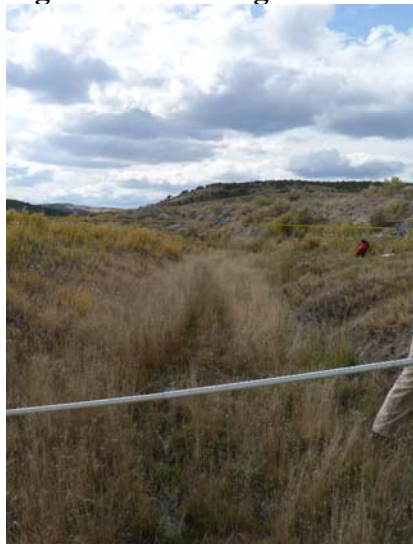
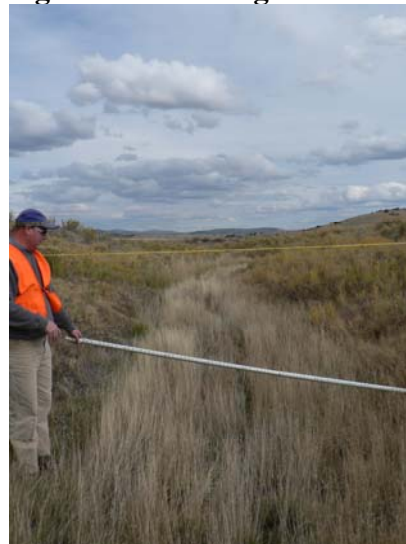
Figure 19: Cross sectional profile below Peterson Draw Reservoir #1

Peterson Draw (below Reservoir #1) 10/2005

Figure 20: Looking US at cross section

Figure 21: Looking DS at cross section

Flow in Peterson Draw is primarily controlled by perennial springs located on private lands near the headwaters. At this location (figures 19-21), flowing water is perennial and a functional riparian community exists. Peterson Draw Reservoir #1 is located approximately 200 yards up stream of the above cross section location. No maintenance on the reservoir has occurred since its initial construction. Due to the lack of regular maintenance, reservoir #1 has trapped large amounts of sediment and needs to be cleaned in order to maintain functional water storage capacity.

A small overflow channel allows water to exit reservoir #1 and is responsible for maintaining the existing riparian community and developing new channel characteristics below county road #16. Estimated bankfull area below reservoir #1 is 1.318 ft². This estimation is probably accurate based on the muted flow regime (~less than 1 cfs) the system has experienced following construction of reservoir #1 in 1953.

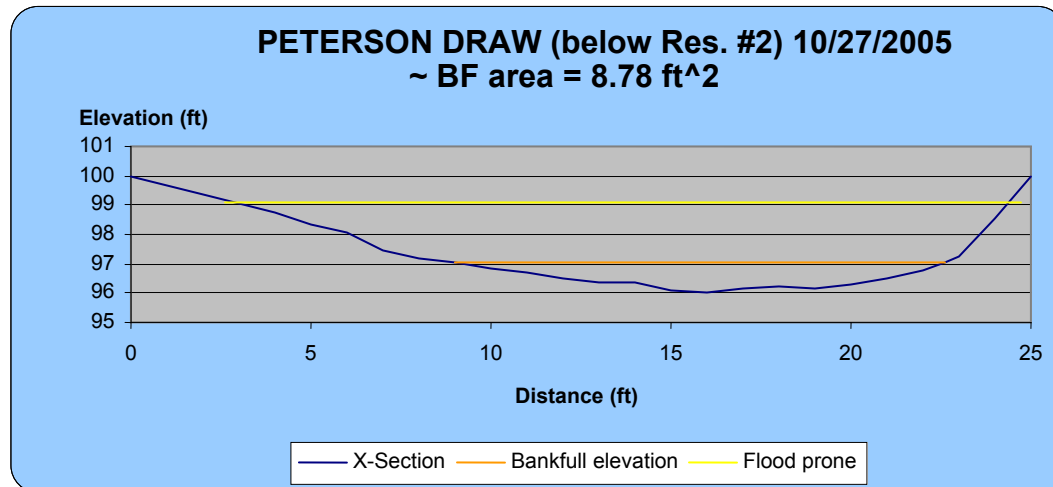
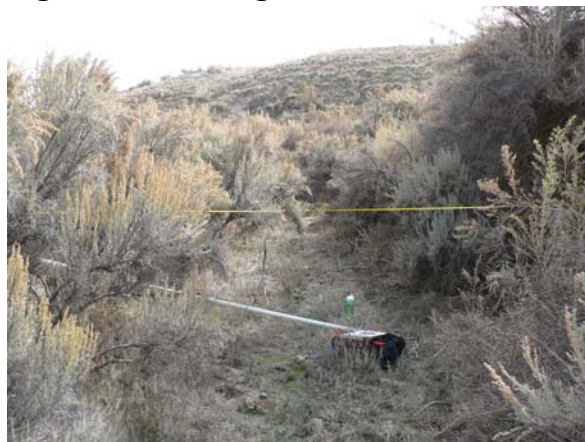
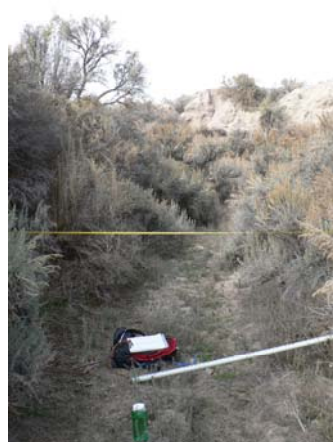
Figure 22: Cross sectional profile below Peterson Draw Reservoir #2.

Peterson Draw (below reservoir #2) 10/2005

Figure 23: Looking US at cross section

Figure 24: Looking DS at cross section

Figures 22-24 are located approximately 100 yards below Peterson Draw Reservoir #2. Note the lack of riparian vegetation and the absence of well defined channel characteristics. Bankfull area was estimated at ~ 8.78 ft² which is probably representative of historic flow regimes prior to reservoir construction in 1958. The embankment and spillway were reconstructed in May of 1992. No records of when the blowout occurred have been found. At the present time the above reservoirs contain nearly enough storage capacity to contain runoff from precipitation and snowmelt. However, the upper portion of the reservoir is trapping significant amounts of sediment and will need to be cleaned in the near future to maintain functional conditions.

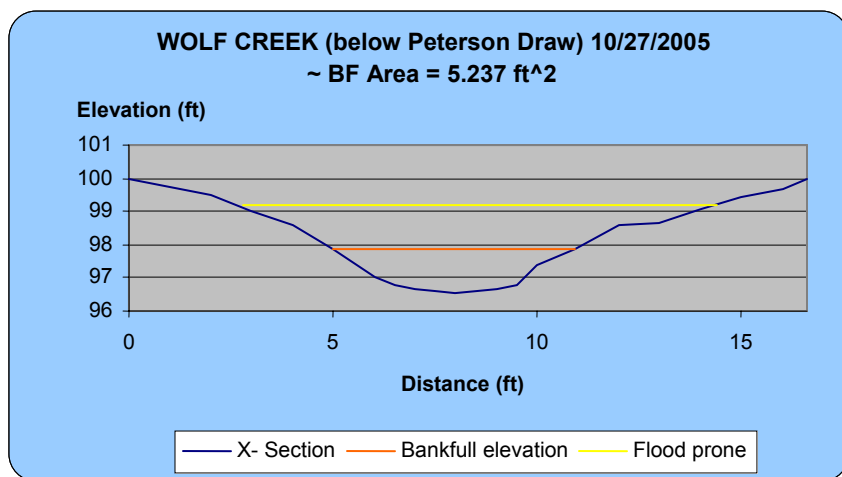
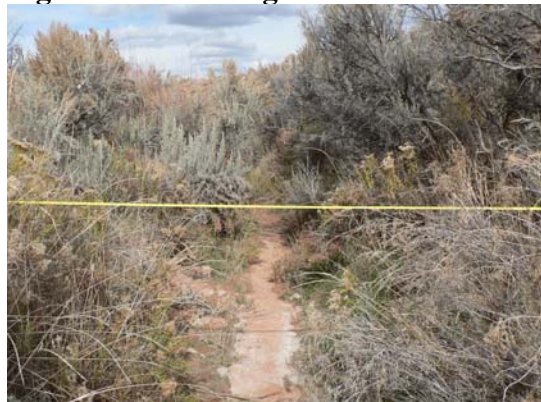
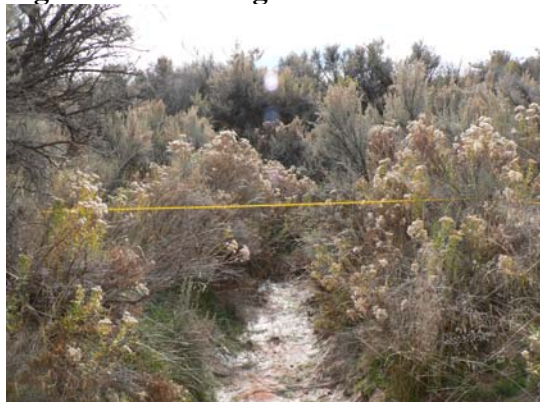
Figure 25: Cross sectional profile of Wolf Creek below Peterson Draw.

Figures 25-27 are located in the main stem of Wolf Creek approximately 50 yards below the confluence with Peterson Draw. As evident in the photos, this reach lacks riparian vegetation and contains flow only in response to spring snowmelt and high intensity precipitation events. Bankfull area was estimated at 5.237 ft² which is significantly low considering the drainage area behind this point (~65,000 acres). Numerous stock ponds exist in the Wolf Creek drainage above this location (many are located on private lands in the headwaters of the catchment area).

Wolf Creek (below Peterson Draw) 10/2005

Figure 26: Looking US at cross section

Figure 27: Looking DS at cross section
